STAFF RECOMMENDATION

SUBJECT: Evaluation of Significance to Rockville of 19 and 20 West Montgomery Avenue

DESCRIPTION: Rockville Town Center, Block 4 Subdivision Lot P21

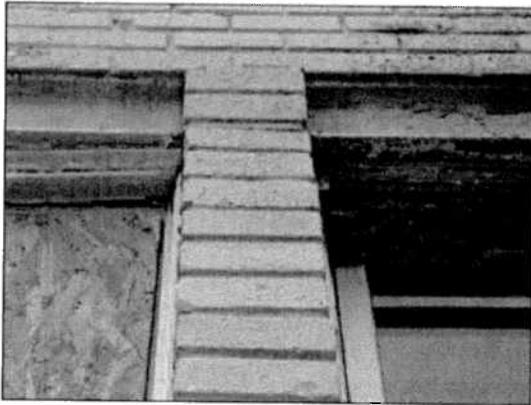
18 West Montgomery Avenue, façade detail

The east bay of the façade is characterized by tripartite fenestration (-w-d-w-) topped by three transoms. The central double door is a recent replacement. The brick piers that separate the windows and door openings are stacked stretcher bricks that do not follow the overall course pattern of the brick façade. These piers may be only facing material. A metal I-beam is the lintel of the openings. The windows have stone sills and the door threshold is stone.

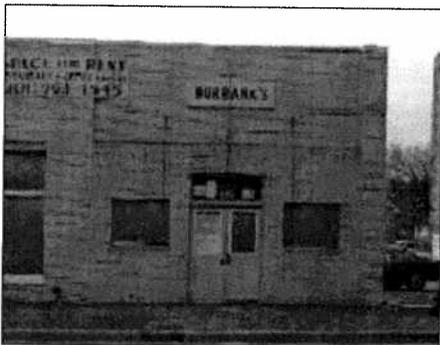
West bay of facade

The West Bay of the façade is characterized by a two-thirds height brick infill that builds out the façade so that it is flush with the piers. Bricks used for this infill wall are more textured than the other façade bricks. An additional brick type was used to patch previous window openings on the west façade bay. The top or cornice line of the infill consists of a brick header row. The only transom is above the door and it is $\frac{1}{2}$ the height of the east bay transoms. The west bay window openings are approximately half the size of the east bay windows. These windows are boarded over, but their slightly projecting brick header sills are evident. The painted metal double doors appear to be recent retail stock items. The brick wall above the infill contains numerous pieces of hardware that likely supported a variety of different signs.

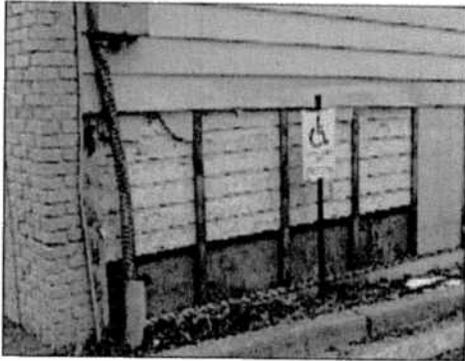
West elevation with German Siding,
November 2007

The west elevation of the building is completely covered with recent vinyl siding. A photograph taken before the repair of the west elevation's vinyl siding indicates wood German siding underneath. The east elevation is faced with stucco. The three vinyl windows have been recently installed and are trimmed with wide painted wood surrounds.

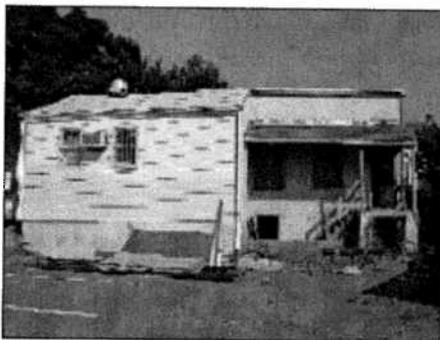
Rear elevation, November 2007

The rear of the east bay has recently been altered by an incomplete construction project. The east half of the rear elevation is recessed from the west rear addition. Two 1/1-sash windows and a rear door pierce the wall. The pre-construction photo on the left indicates the door was fronted by a stoop with side stairs supported by cement block piers. A shed roof was located above the windows about 2' below the roof and was supported by two posts on the stoop.

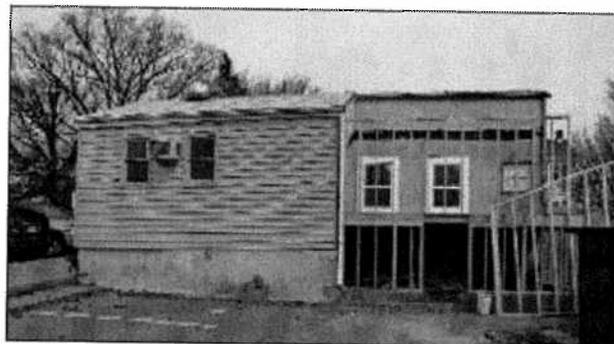
Rear elevation, current

The recent construction project has resulted in the removal of the shed roof, stairs, and stoop. A platform is built out at the door level and extends to the rear wall plane of the west bay rear elevation. A cement block foundation has been laid under the perimeter of the platform and the back wall has been framed out. The windows have been replaced with 1/1 vinyl with wide plain board surrounds, similar to those found on the east elevation.

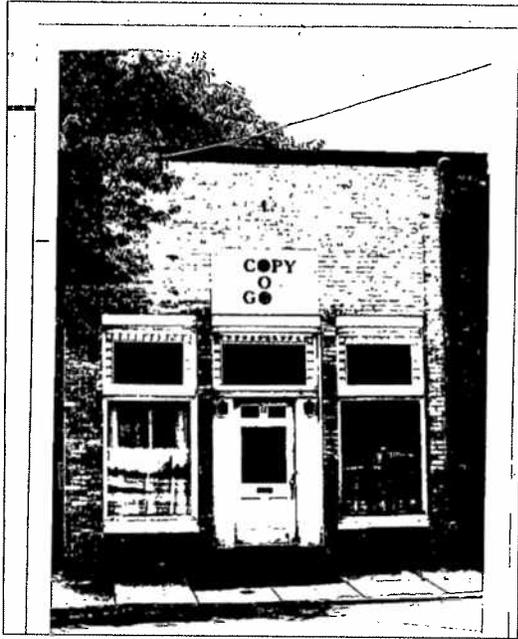
Rockville Historic Buildings and Districts Survey Form, 1976
18 West Montgomery Avenue

A 1976 City of Rockville Historic Building Inventory form contains a picture of the east bay of Burbanks, which was a "Copy to Go" store at the time. The image is from a scanned file and is not very clear. The picture shows Dentil Row moldings lining the inside of transom windows,

were probably contemporary trim applications. The eastern window appears by divided into four rectangular lights, which could have dated from the building's original construction. The top of the building has a dark band across it, which could be a former cornice element, or only paint. The small part of the west bay in the photo is much darker, suggesting the brick façade was painted two different colors.
