May 2009

# City of Rockville Pedestrian Inventory Study Safety and Accessibility Evaluation

Rockville, Maryland

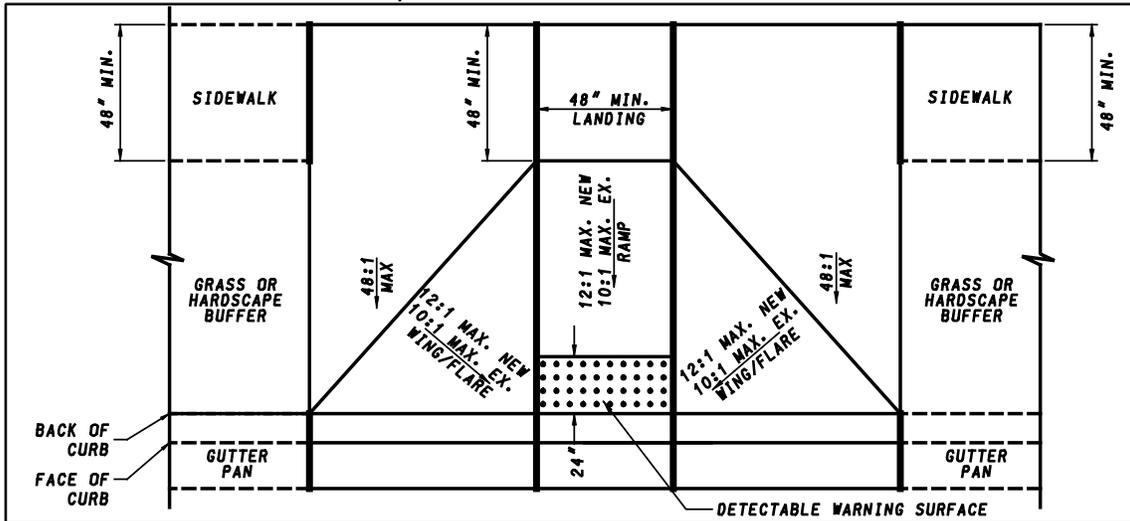
Figure 1 – Perpendicular Ramp

1. *Ramps* – Describes the location, alignment (perpendicular or diagonal relative to crossing), type (perpendicular or parallel), geometrics (dimensions and slopes), obstructions and condition of the sidewalk ramps within the crossing area. The ramps are evaluated based on Federal (ADA) and/or State accessibility guidelines to ensure all pedestrians can safely access designated crossings from adjacent sidewalks. Some key federal minimum requirements include:
  - Flat landing area (2% minimum slope) with a 48” minimum width
  - Existing ramp and wing within the walking path with a 10:1 minimum slope
  - Detectable warning surfaces on all ramps and median cut-through sections
  - 3’ minimum clear width from obstructions on ramps

Figures 1 and 2 illustrate the features of the different types of ramps with their minimum geometric requirements.

The most common ramp deficiencies found were ramps not properly aligned with the crosswalks, slopes of ramp wings (flares) were too steep and the lack of detectable warning surfaces at the bottom of ramps.

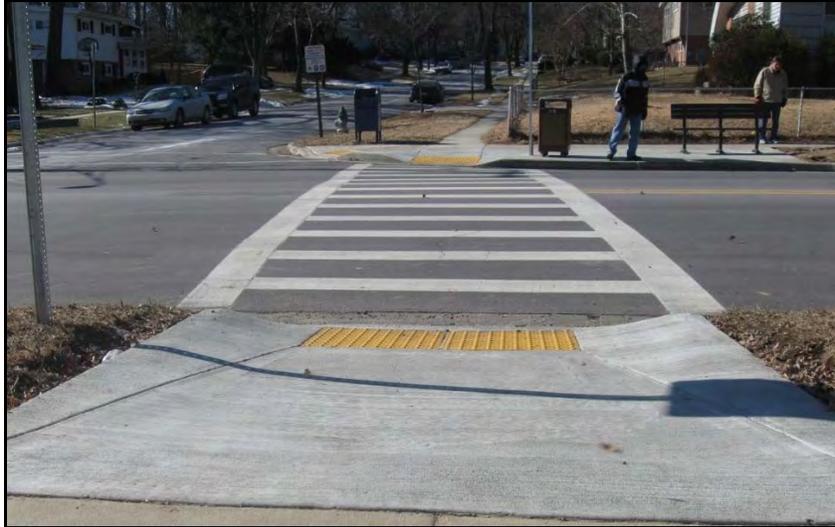
**Figure 3 – Pedestrian Crosswalk**

roadways. The crosswalks are evaluated based on Federal and/or State accessibility and traffic control device guidelines to ensure all pedestrians have uniformly designed marked pathways to identify where to safely cross roadways. **Figure 3** illustrates an example of a crosswalk in Rockville.

The most common crosswalk deficiencies found were faded pavement markings that needed to be restriped.

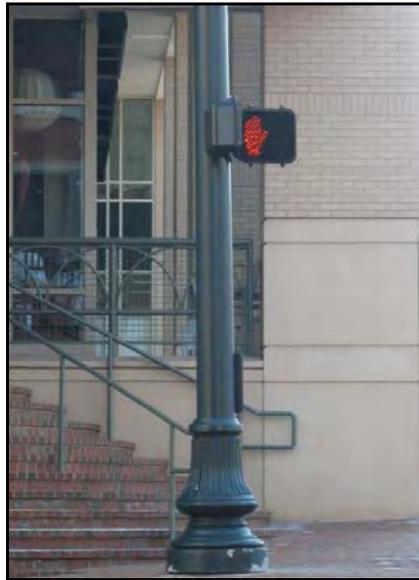
**Figure 4 – Pedestrian Signal**

4. *Pedestrian Signals* (Signalized locations only) – Describes the location, type and condition of pedestrian crossing indications. The pedestrian signals are evaluated based on Federal and/or State traffic control device guidelines to ensure all pedestrians with or without visual impairments have a uniformly designed indicator to notify when to safely cross roadways. **Figure 4** illustrates an example of a pedestrian signal in Rockville.

A mixture of pedestrian signals with and without countdown capabilities can be found throughout Rockville. Countdown signals (CPS) are not a federal requirement; however the State had been systematically upgrading all of the pedestrian signals at their intersections (which are maintained by Montgomery County) with CPS. Recommendations to upgrade pedestrian signals to CPS are made at State roadway intersections only, however the City has plans to systematically upgrade their pedestrian signals to meet State CPS recommendations. The most common pedestrian signal deficiencies found were the lateral distance of the signal relative to the crosswalk were not to standard width (5' minimum).

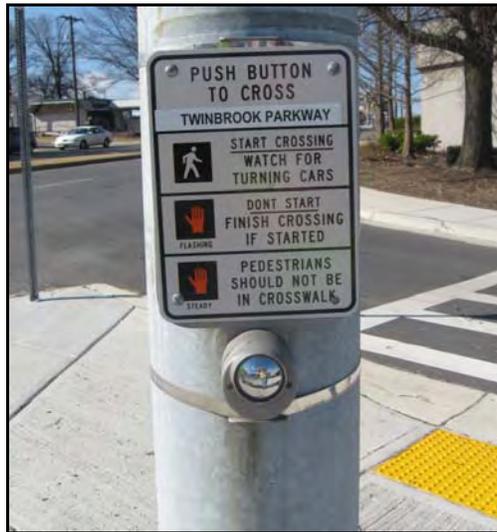
Figure 5 – Pedestrian Push Button

- Accessible from sidewalk near end of crosswalk
- 3.5' maximum height
- Sign and push button oriented parallel to crosswalk

**Figure 5** illustrates an example of a pedestrian push button in Rockville.

A mixture of pedestrian push buttons with and without Accessible Pedestrian Systems (APS) capabilities can be found throughout Rockville. APS are not a federal requirement; however the State upgrades all of the push buttons at their intersections with APS. Recommendations to upgrade push buttons to APS are made at State roadway intersections only, however the City has plans to systematically upgrade their pushbuttons to APS in the future. The most common push button deficiencies found were improper orientation and height of push buttons relative to their crossing.

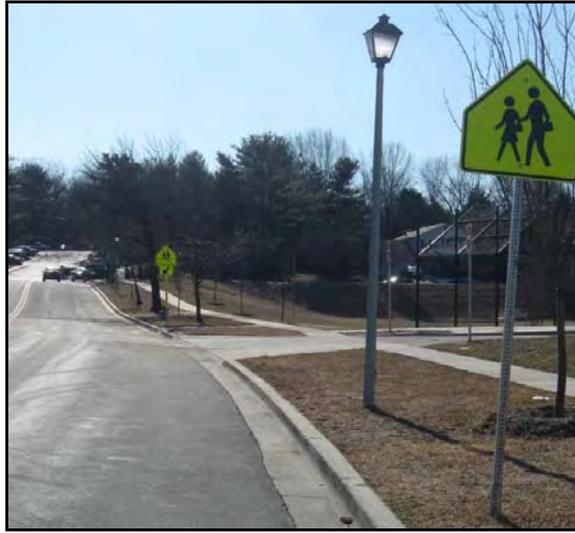
Figure 6 – School Pedestrian Crossing Signing

7. *Pedestrian Signing* – Describes the location (advanced warning or at the crossing) and type of signing specifically for the pedestrian crossings. The pedestrian signs are evaluated based on Federal and/or State traffic control device guidelines to ensure all motorists are aware of the approaching pedestrian crossings with uniformly designed signing. **Figure 6** illustrates an example of a school zone pedestrian crossing sign sequence in Rockville. The most common sign deficiencies found were the lack of supplemental arrow signs beneath pedestrian crossing signs at the crossings and use of old pedestrian/ school crossing type signs.

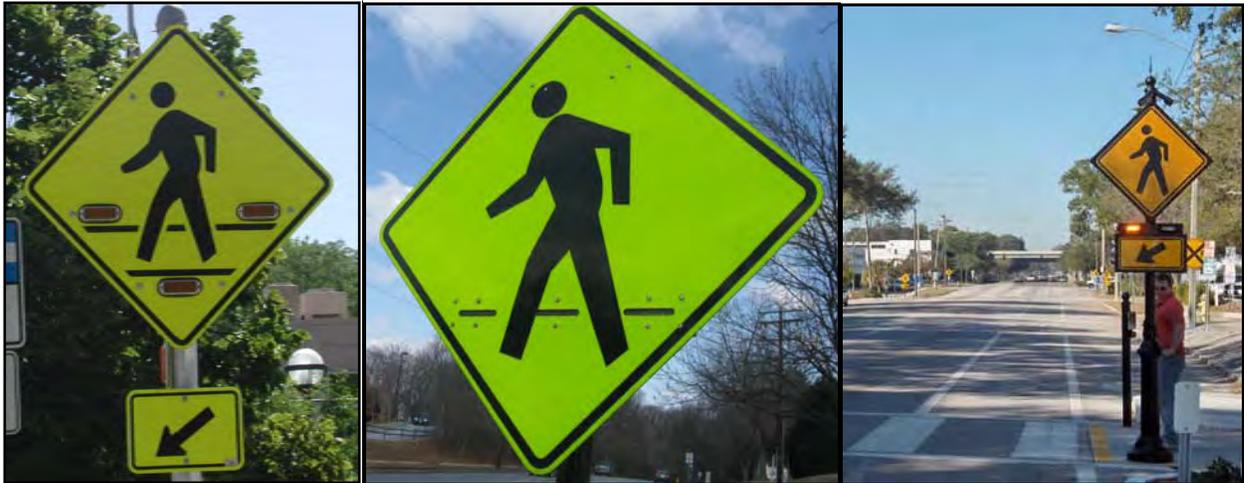
Figure 8 – LED Lights in Pedestrian Crossing Signs

- *Sign Lighting* – Incorporate LED lights into pedestrian crossing signs to enhance the presence and visibility of the signs. The lights begin to flash once actuated by a push button. This device is currently being used in Rockville at the intersection of Twinbrook Parkway and Twinbrook Community Center. **Figure 8** illustrates examples of different types of sign lights in pedestrian crossing signs. This device has been federally approved (see MUTCD Section 2A.08).

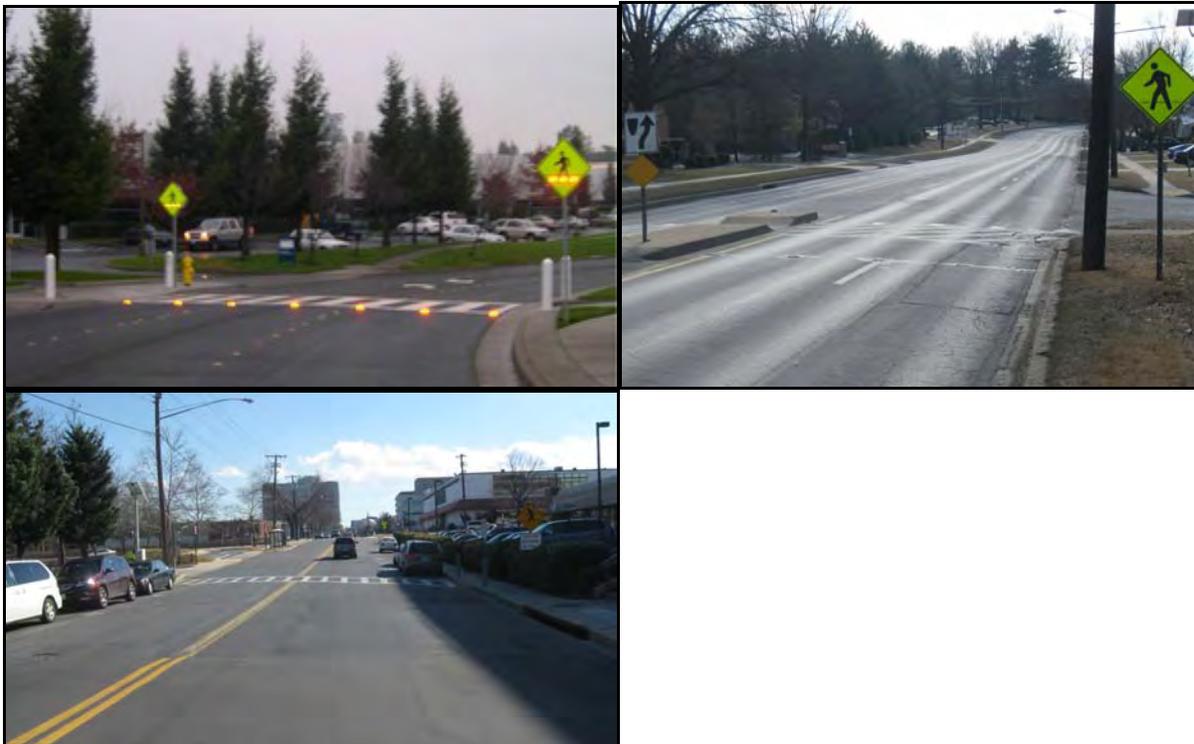
Figure 9 – In-pavement Lights at Crosswalks

- *Crosswalk Lighting* – Incorporate lights into the pavement along crosswalks to enhance the presence and visibility of the crosswalk. The lights begin to flash once actuated by a push button or pedestrian presence detector. This device is currently being used in Rockville at the intersection of Twinbrook Parkway and Twinbrook Community Center and along Chapman Avenue between Bouic Avenue and Halpine Road to access the Twinbrook Metro Station. **Figure 9** illustrates examples of in-pavement lights at crosswalks. This device has been federally approved (see MUTCD Section 4L.01).

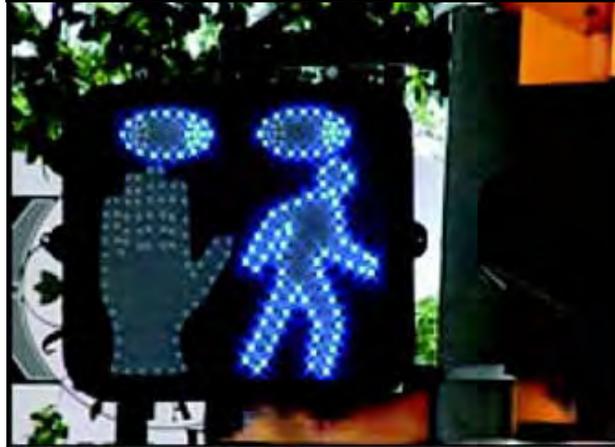
Figure 10 – Pedestrian Signal Eye Display

- *Pedestrian Signal Eye* – Pedestrian signal with white LED animated eyes display above the WALK and DON'T WALK displays that scan left to right at a rate of one cycle per second. This device promotes pedestrians to look left and right prior to crossing. **Figure 10** illustrates an example of a pedestrian signal eye display. This device has been federally approved (see MUTCD Section 4E.04).

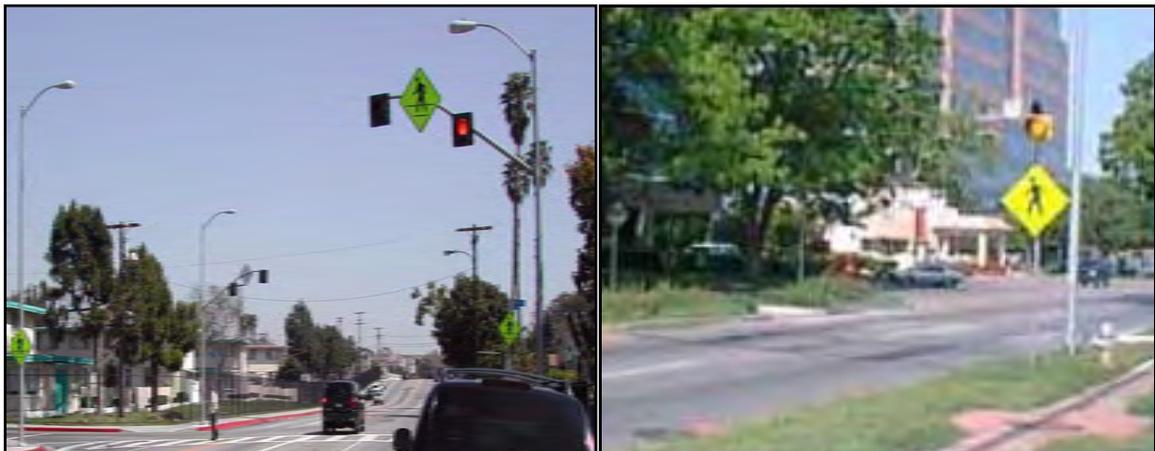
Figure 11 – Pedestrian Crossing Flashing Beacon

- *Pedestrian Flashing Beacons* – Incorporate flashing amber signals adjacent to pedestrian crossing signs to enhance the presence and visibility of the signs and crossing. The lights can be pre-empted to flash once actuated by a push button. **Figure 11** illustrates examples of different types of pedestrian flashing beacons. This device has been federally approved (see MUTCD Section 4K.03).

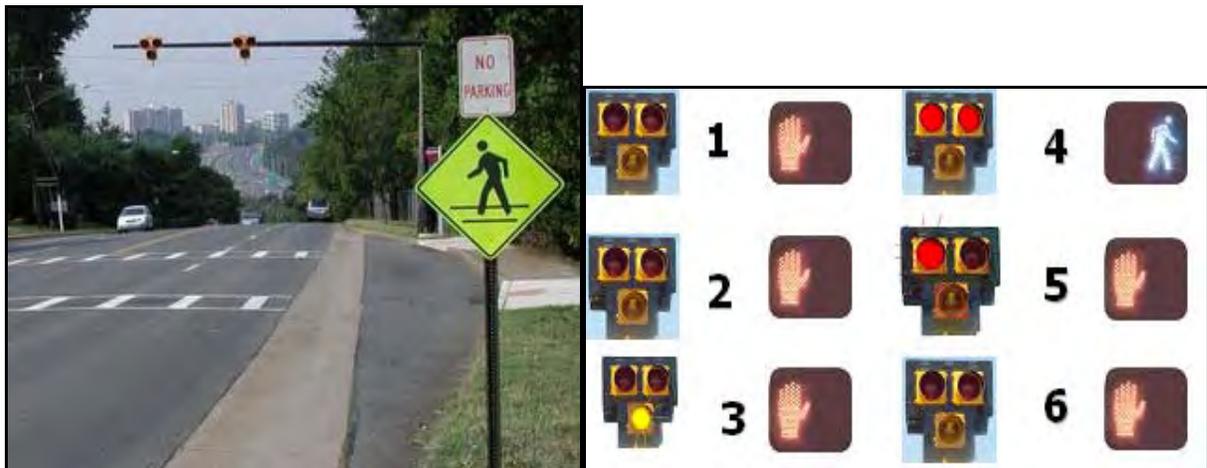
Figure 12 – HAWK Signal and Signal Sequencing

- *High-Intensity Activated Cross Walk Beacon (HAWK)* – A traffic signal that has two round red lenses side by side above a single yellow lens, and only lights up when actuated by a pushbutton. This device has an interim federal approval and is expected to be adopted in

the future MUTCD. **Figure 12** illustrates an example of a HAWK beacon and the sequencing of the different signal indications. The phase sequencing as shown in **Figure 12** is as follows:

1. The HAWK is dark when not actuated. The conventional pedestrian signal heads at either end of the crosswalk are in DON'T WALK mode.
2. When actuated the HAWK beacon first flashes yellow. The pedestrian signal heads are in DON'T WALK mode when the HAWK beacon is activated.
3. Then goes to steady yellow while the pedestrian signal heads are still in DON'T WALK mode
4. Finally steady red, where sequence 2-4 occurs over a period of several seconds. The pedestrian signal heads go to WALK mode when the HAWK beacon goes to steady red.

Like a conventional signalized crossing, the pedestrian signals go to flashing DON'T WALK when typical pedestrians would no longer be able to get all the way across during the time the HAWK beacon stops cross traffic.

5. When cross traffic is about to restart, the pedestrian signal goes to steady DON'T WALK. At or near the same time as the DON'T WALK indication, the HAWK beacon goes to flashing red (the equivalent of a stop sign), indicating that vehicles on the roadway may proceed if pedestrians have cleared the crosswalk.
6. Then, finally, the HAWK beacon goes dark.

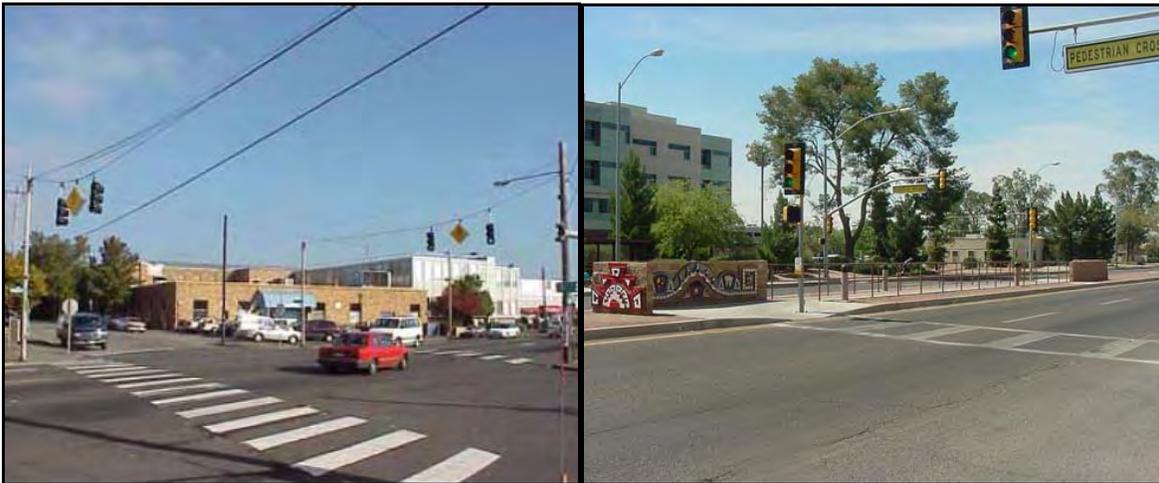
Figure 13 – Half Signals

- *Half Signal* – A vehicular traffic signal that is actuated by a push button used to stop traffic for pedestrians at a stop-controlled intersection or mid-block crossing. **Figure 13** illustrates examples of different types of half signals. This device has not been federally approved.

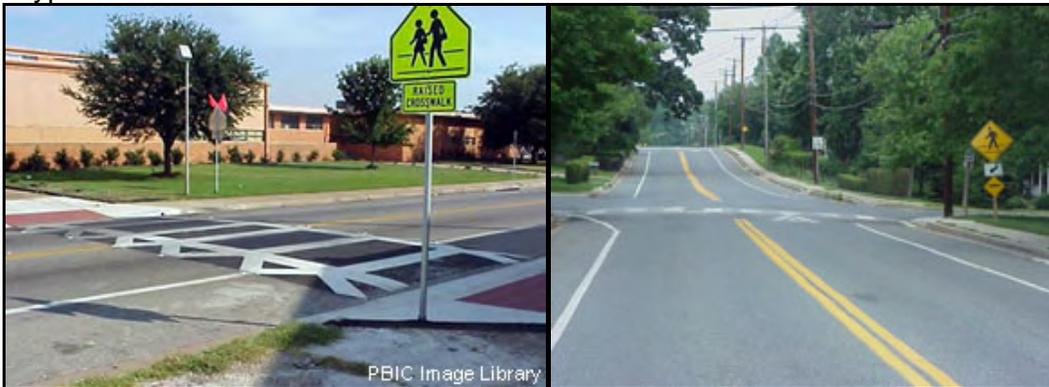
Figure 14 – Raised Crosswalk

- *Raised Crosswalks* – A speed hump/table that incorporates a crosswalk to slow motorist as they approach the uncontrolled crossing. **Figure 14** illustrates examples of different types of raised crosswalks.

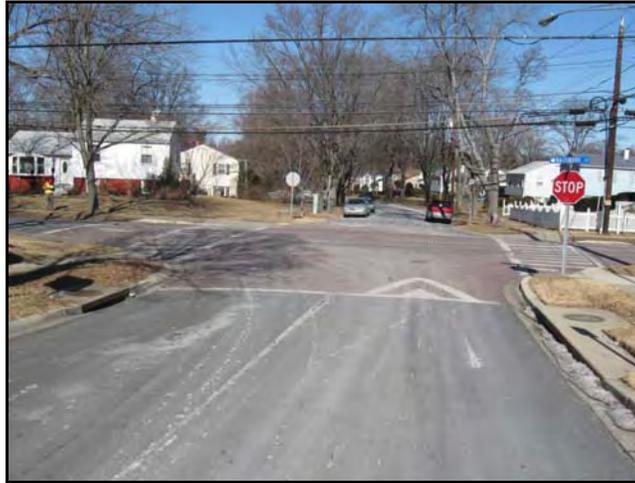
Figure 15 – Raised Intersection

- *Raised Intersections* – A large speed table that spans through an intersection and a pedestrian crossing to slow motorist as they approach the crossing and the intersection. As shown in **Figure 15**, this device is currently being used in Rockville at the intersection of Baltimore Road and Woodburn Road.

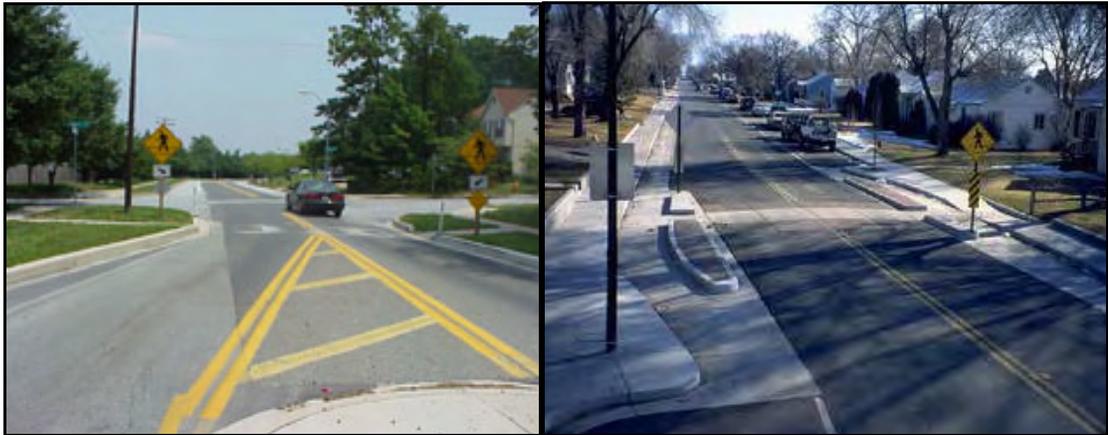
Figure 16 – Chokers at Pedestrian Crossings

- *Chokers at Pedestrian Crossings* – Roadway curblines designed to narrow the roadway cross section at pedestrian crossings. This geometric effect reduces the crossing length for pedestrians and creates an illusion of a narrow roadway to slow down vehicular speeds as motorists approach the uncontrolled crossing. **Figure 16** illustrates examples of different types of chokers at pedestrian crossings.
